# Status of BESSY II and bERLinPro

**Wolfgang Anders**

Helmholtz-Zentrum Berlin for Materials and Energy (HZB)

20th ESLS-RF Meeting 16.-17.11.2016 at PSI

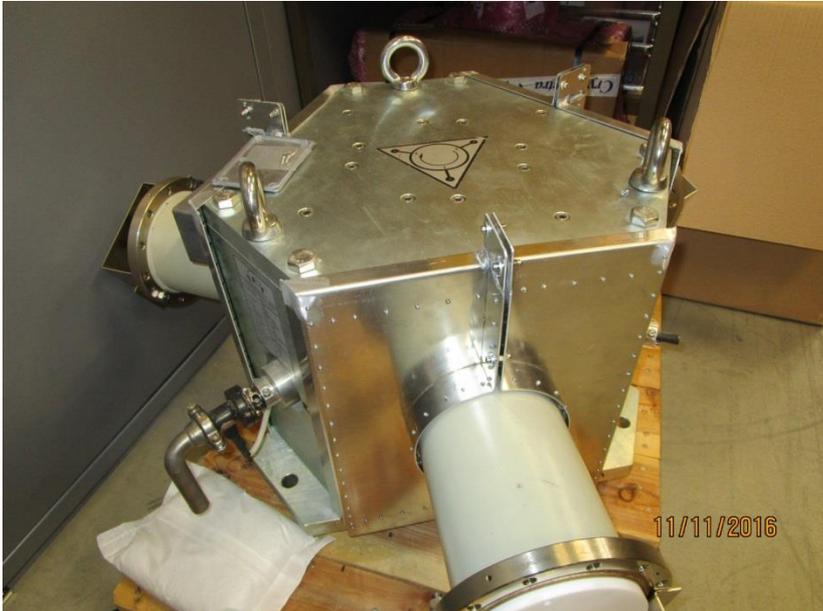
AFT circulator with RF shielding

- We bought new temperature compensation units (TCU) because of aging problems
- All circulators are sent to AFT for adaption
- New TCU units do not work.
  - TCUs switch off transmitters at a temperature slightly too low
  - Potentiometers on maximum setting
- No support by AFT, but they offered a software for a high price to get better settings. → We decided not to buy and run with lower performance
- We detected RF radiation from circulators → adapted a shielding

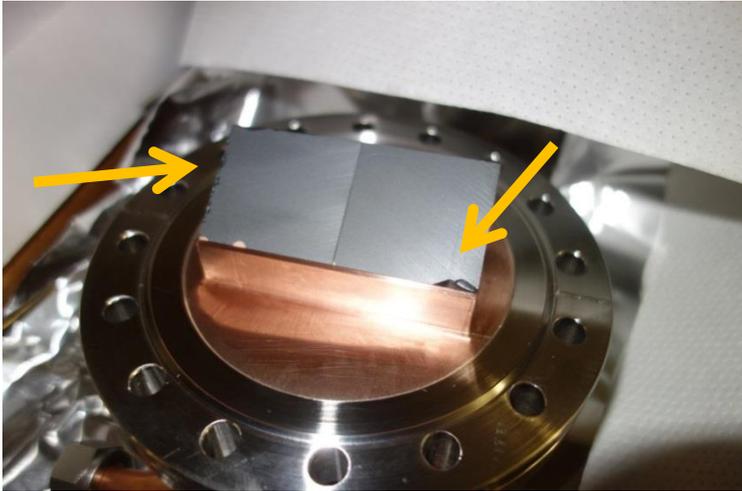
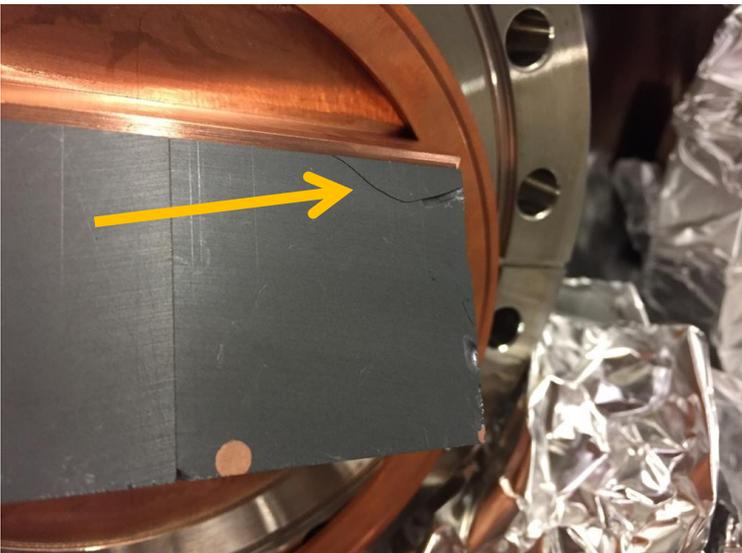
broken ferrite tiles in HOM dampers

- In the cavities we saw broken ferrite (C48) tiles
- Some small ferrite pieces from upper waveguide have been fallen into the cavity body
- Carefully performed search for leakages detected a vacuum leak between body and lit of landau cavity #2
  - → impossible to repair

- Starts at production by SDMS
- Pot and lit have been brazed at 780 °C
- Was leaky, second brazing at 600 °C. Solder contains cadmium making the copper brittle. Still not leak tight. More brazing by hand.
- Due to the high power load it opened a vacuum leakage

- Bended upper HOM waveguides to prevent ferrite pieces to fall into the cavity body
- Smaller ferrite tiles with rounded edges, same as the 500 MHz HOM cavity
- Ports for vacuum pumping and vacuum measurement
- Ports for in situ optical / infrared inspection
- One waveguide with vacuum valve planned as a test station for different absorbers sizes and material (SiC) for bERLinPro and Bessy VSR

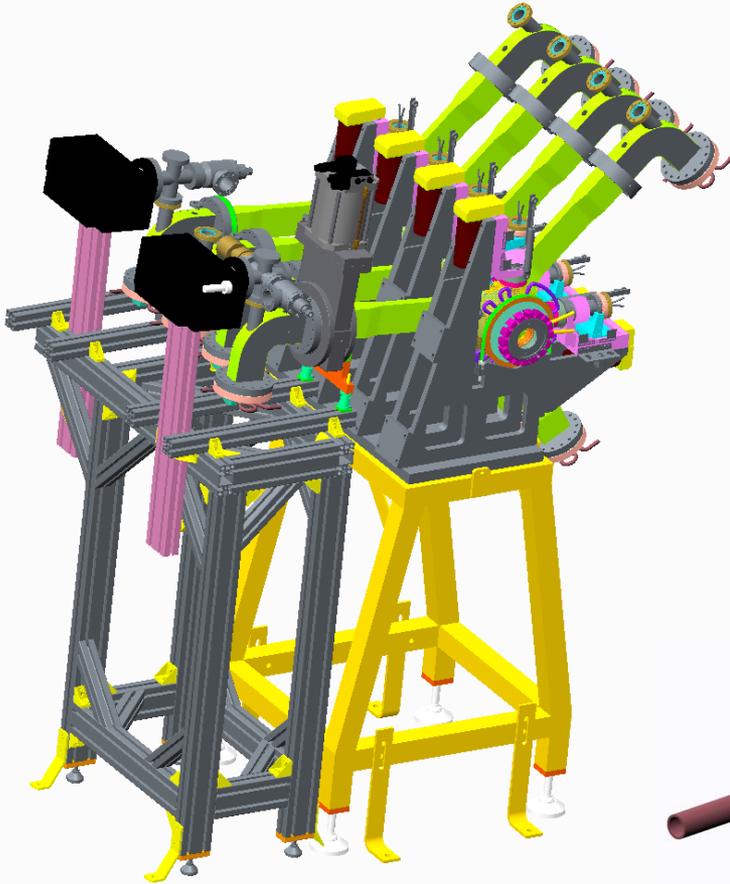
New setup for landau cavities

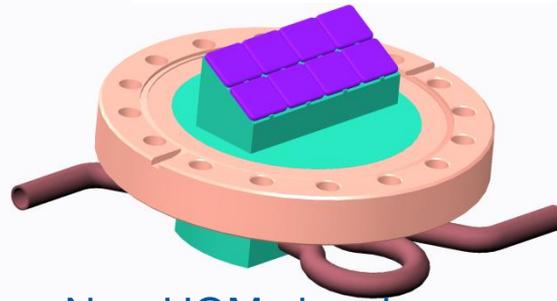
New HOM absorber  
with rounded edges

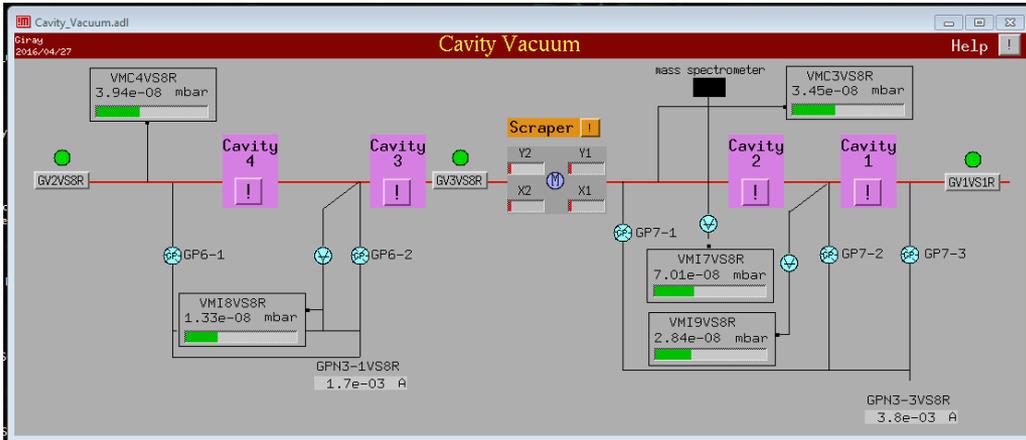
Vacuum reading in cavity section  $10^{-8}$  mbar range

- **2013** two HOM cavities were installed at BESSY II
- No in situ bake out
- Poor vacuum in section ( $10^{-8}$  mbar)
- **2015** next two cavities installed
- Bake out
- Vacuum stays bad for the “old” cavities
- New installed cavities  $10^{-9}$  mbar
- **2016** section opened. Look with endoscope and intensive leak detection → nothing detected
- Spare cavity still in production at RI
- Now spare cavity is delivered
- **2017** still open, if we exchange cavity #2 and section between cavities

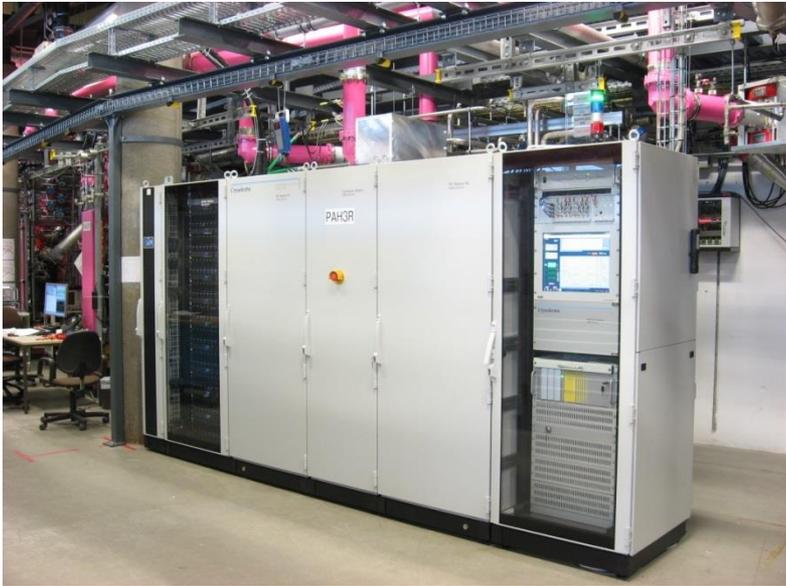
500 MHz 80 kW SSA (Cryoelectra)

- In the shutdown 2015 all modules were resoldered with high temperature solder
- **11 months of operation:**  
**12 modules failed out of 630 modules** (all burned output section in the module)
- **No other failures**
- **No beam loss due to the SSA**
- Best support by Cryoelectra
- Few beam losses by circulator and water
- Few beam losses by work on our PLC

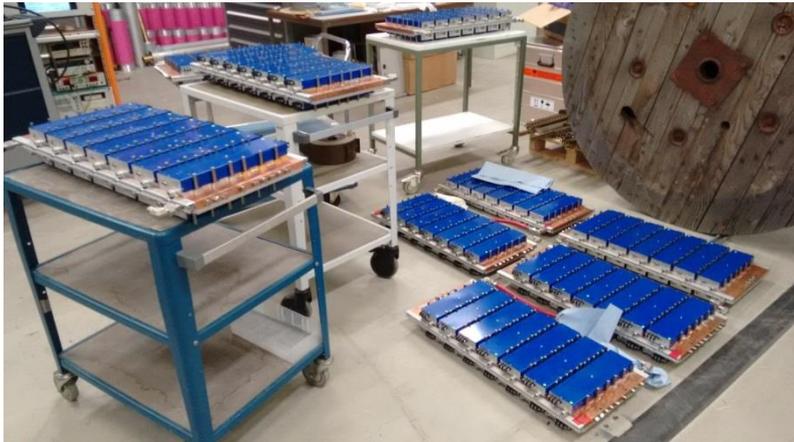
Modules for resoldering

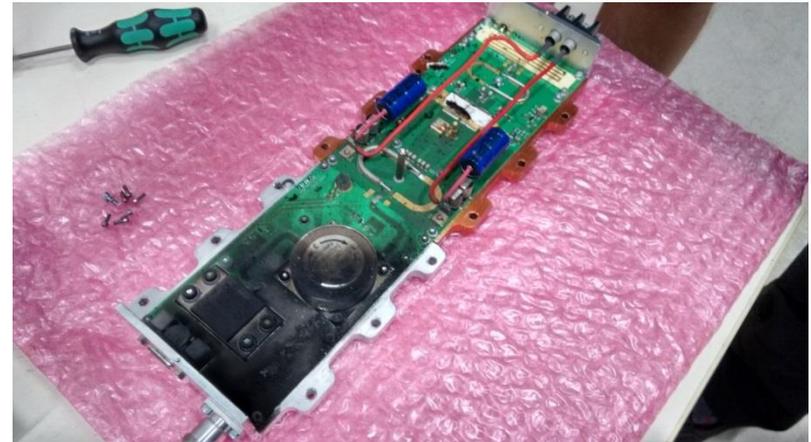
Burned output in a module

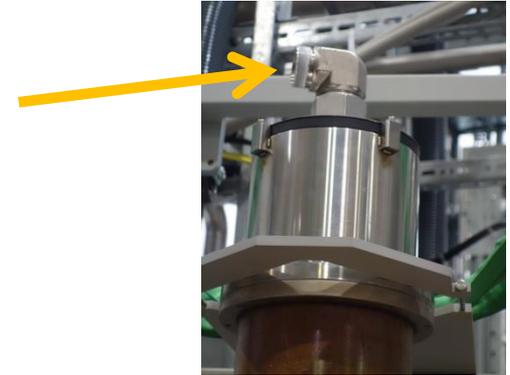
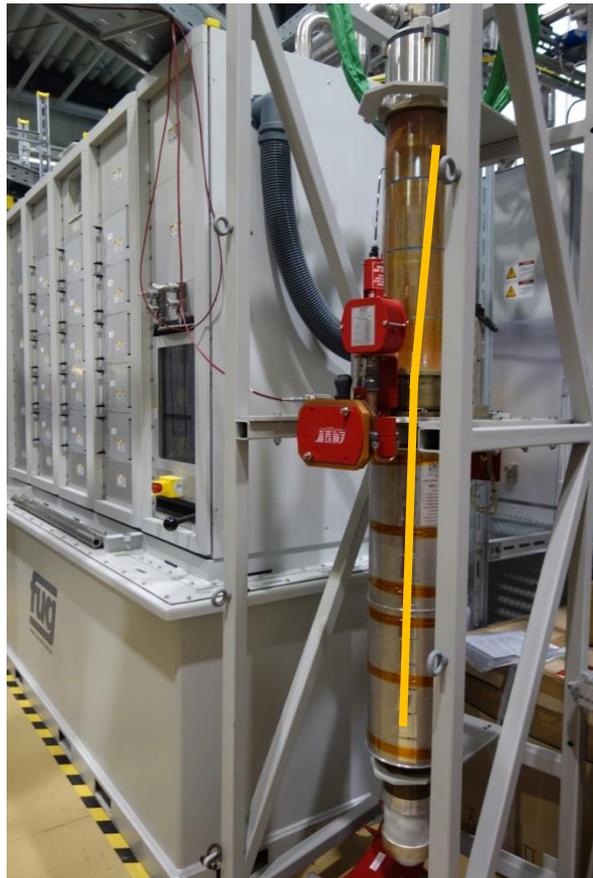
- First klystron was delivered, vacuum o.k.
- There is a large Swagelock water connector at the collector
- CPI fastened the connector → vacuum leakage

- Second klystron was delivered
- Difficult to install in the magnet, because there was a little angle between collector and tube
- CPI assisted to install
- → high body current at different voltage levels
