SOLARIS
NATIONAL SYNCHROTRON
RADIATION CENTRE

Status of Solaris RF system

Marcin Knafel
On behalf of Solaris Team

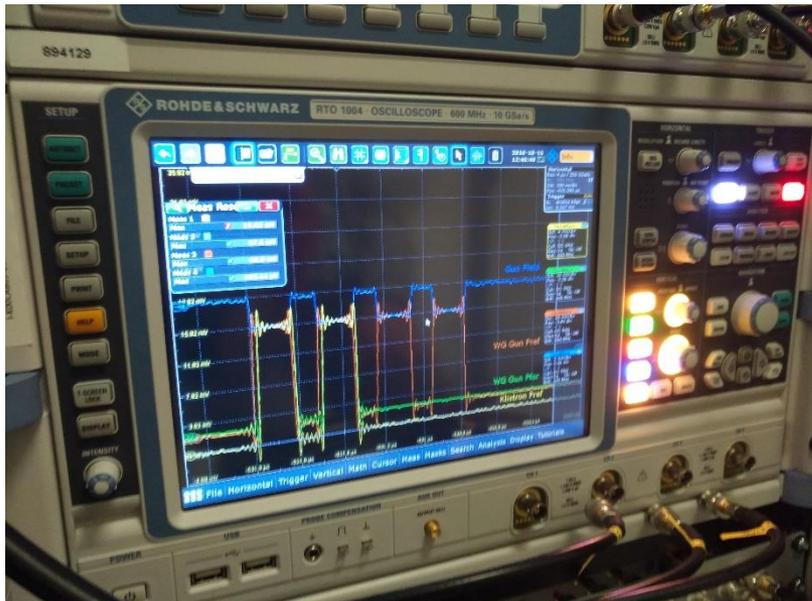
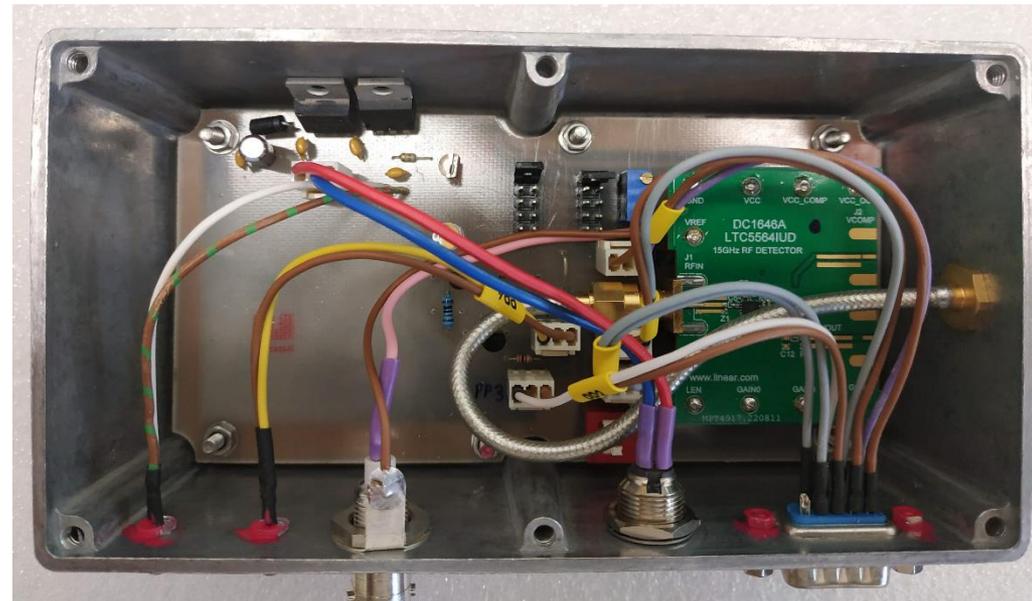
Analog reflected power interlock for Klystrons

- Unreliable performance of Rhode&Shwarz scopes.
- False reflected power interlocks – unable to inject beam.
- Hardware fix – a dedicated module to detect and signal reflected power levels.

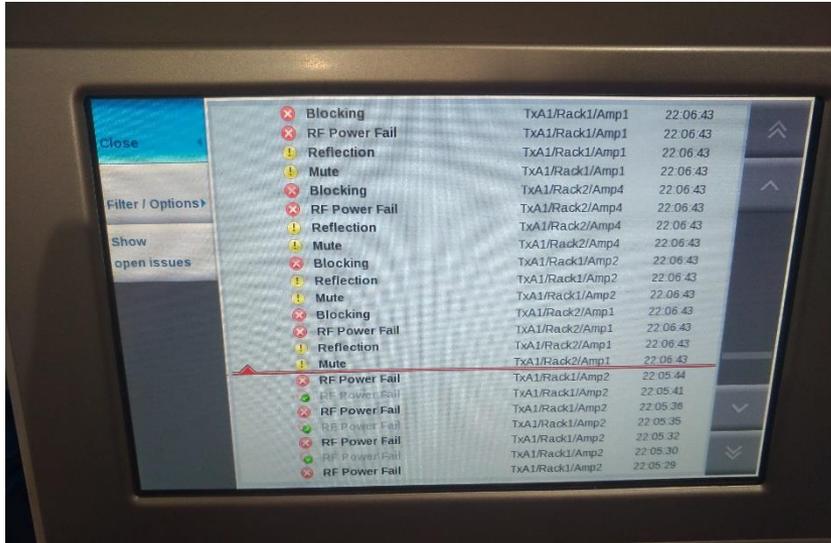
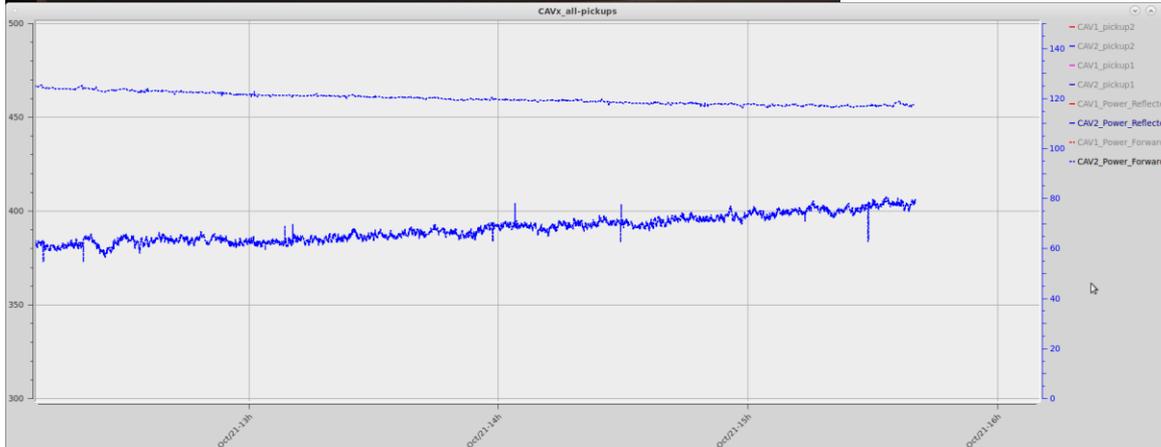
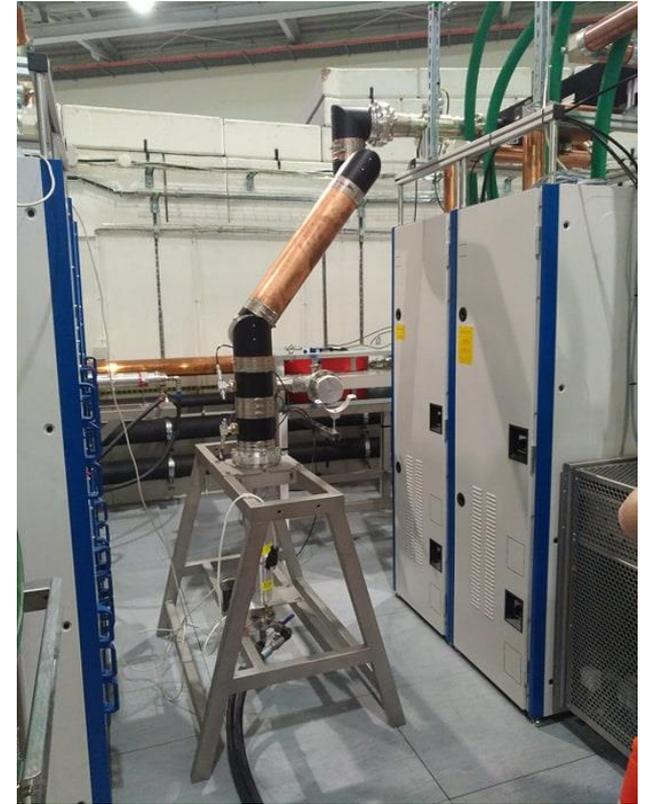
Circulator reflected power issue

- Mysterious beam dumps caused by sudden loss of RF power on Transmitter 2
 - No signs of reflected power peaks in tango
 - Reflected power alerts in Tx2 GUI
 - Extensive testing carried out
 - Final blame put on Circulator

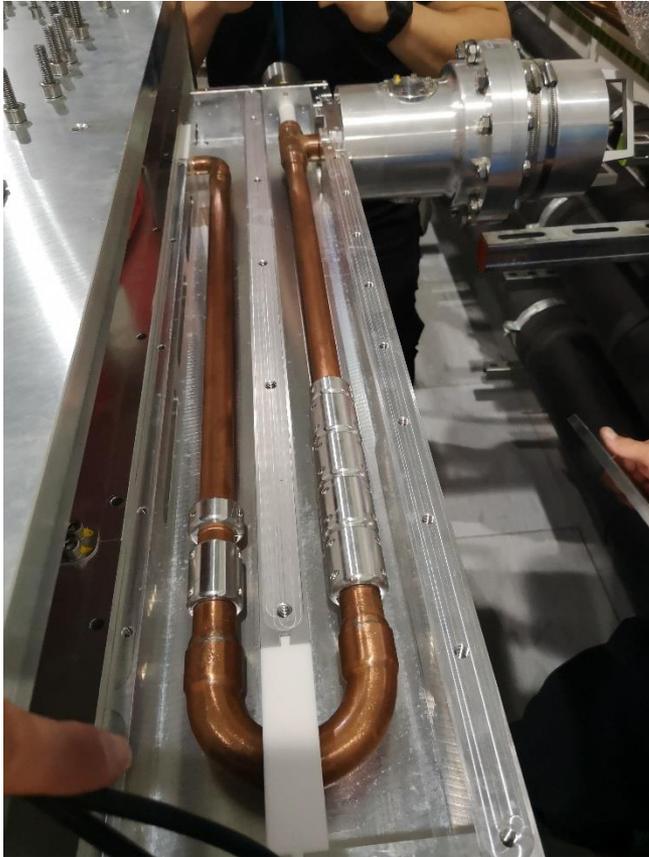
OUTPUT PORT

- AFT service called in to inspect the insides of the circulator

- Solder joints of „hot” conductor were faulty (probably manufacturing defect) – cooling water leaked into the coax line
- RF mismatch caused arcing inside, that wasn't detected by fiber optics
- Sudden large spikes of reflected power above 23kW Pfor
- Severe corrosion of copper conductor

- Damaged teflon separator replaced with a new one, made to order
- New piping installed and soldered in place
- Impedance matching with ferrite beads carried out
- Final measurements taken every week for about 2 months after repair concluded, that circulator is entirely operational and fixed

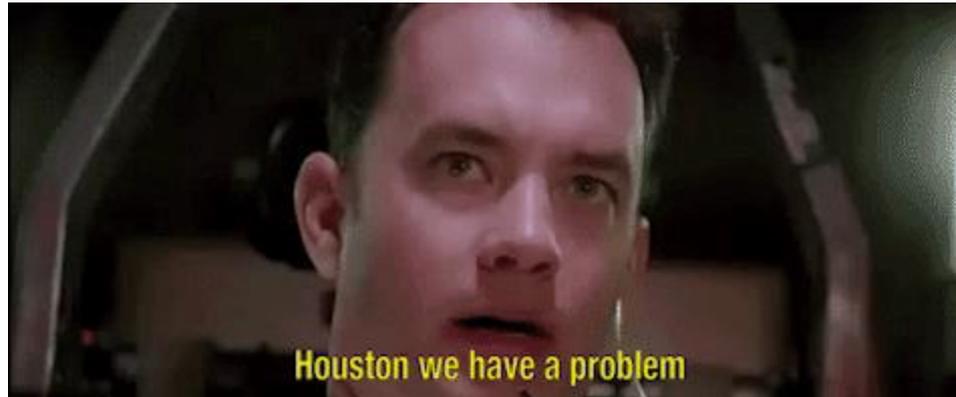
OPERATION IMPOSSIBLE – IMMEDIATE SERVICE ACTION NEEDED

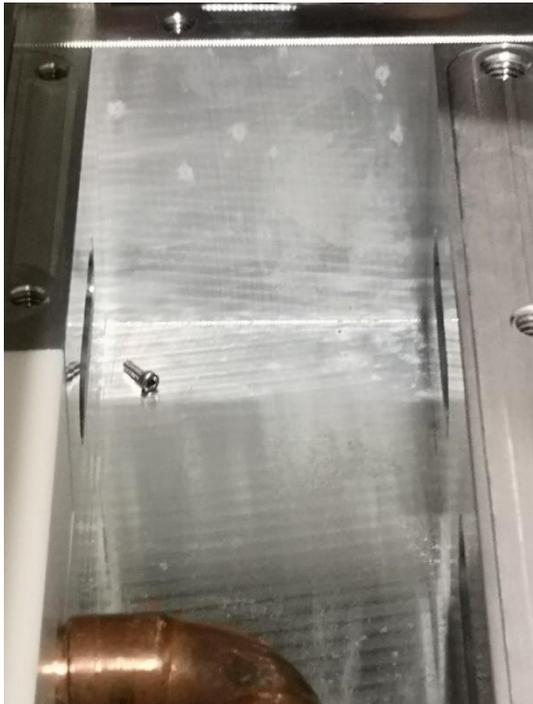
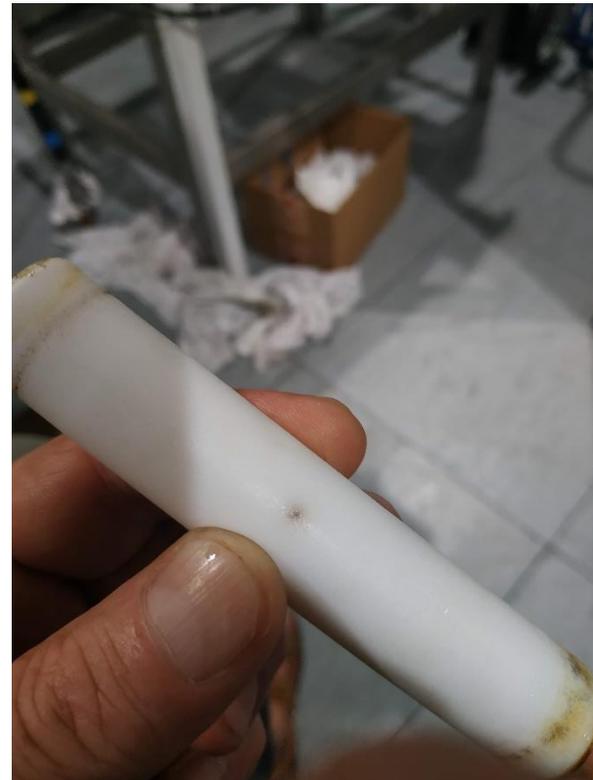
Some things still left us wondering...

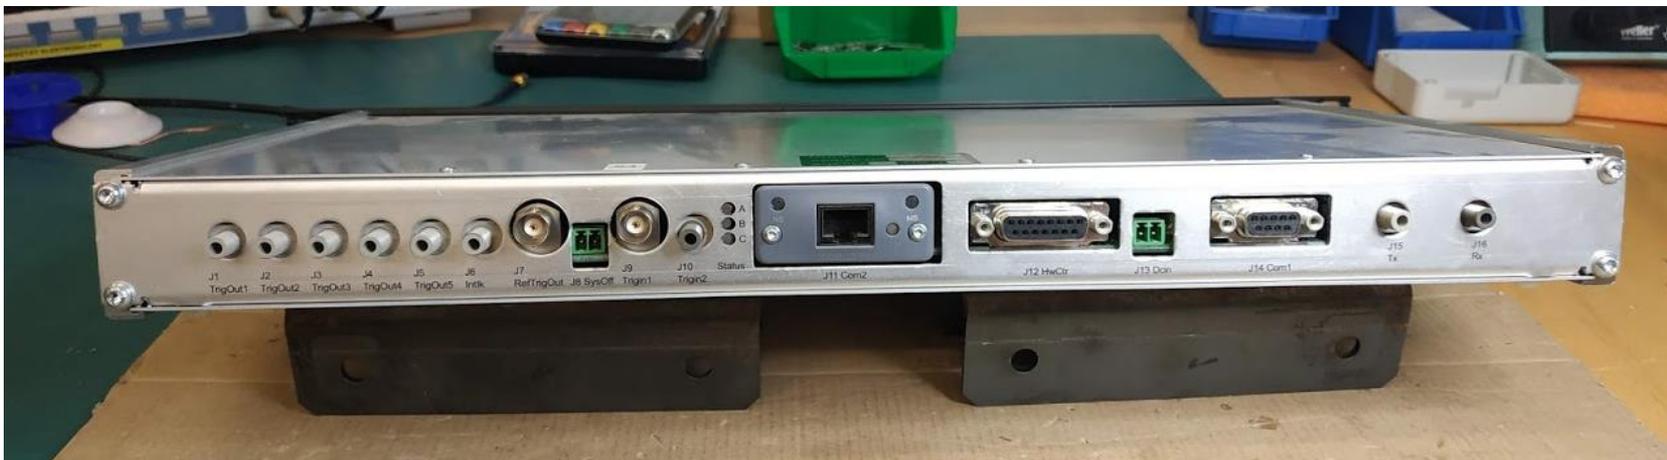
K00 Modulator MCU fail

- After a 2-week shutdown, modulator K00 would not start
- „No communication” error
- Faulty MCU diagnosed
- Spares turn out to be faulty as well...
- Quick reaction from ScandiNova, replacement spare parts were sent free of charge the next week
- New set of spares ordered outright

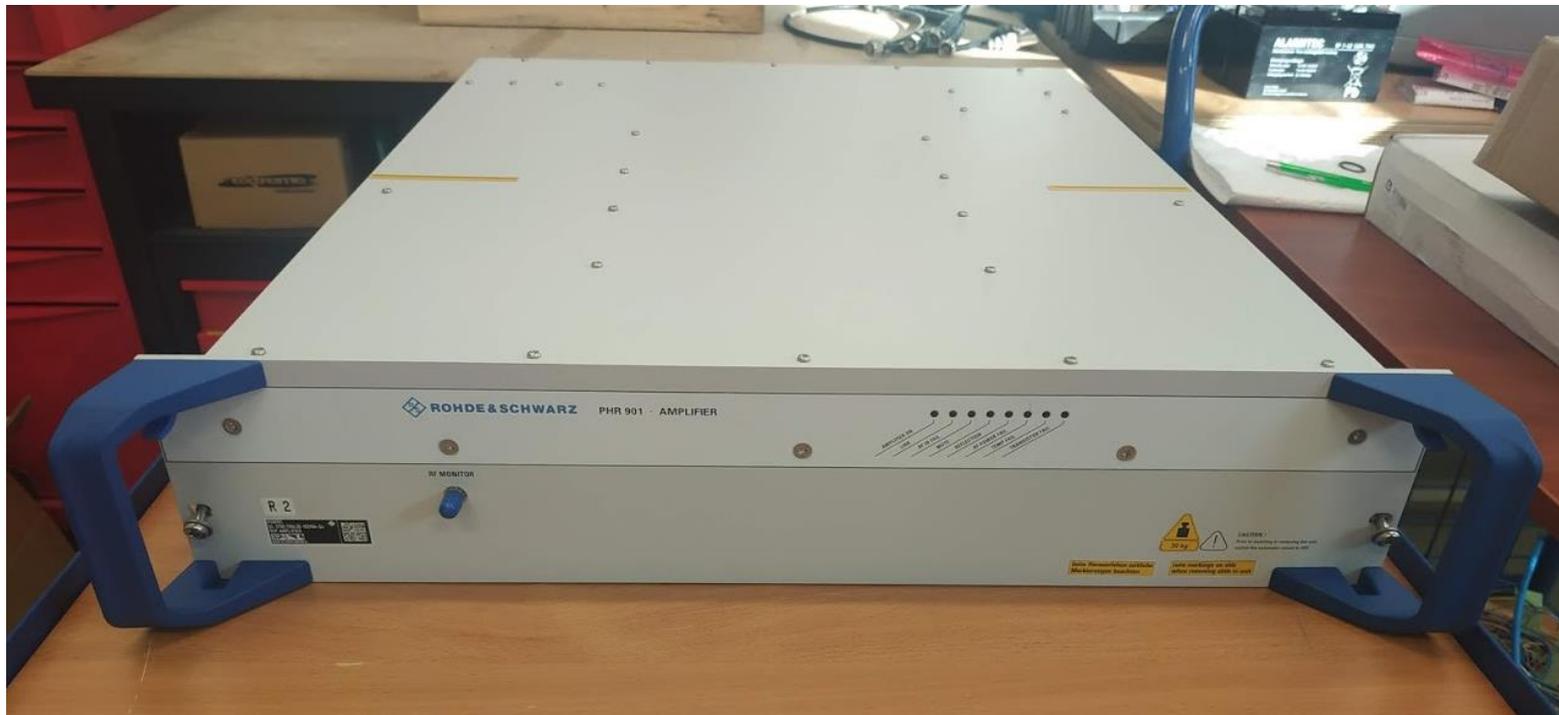
Several faulty PHR901

- Most PHR901 amplifiers reaching end of warranty
- Amplifiers notoriously fail due to dead PSU
- Each fault takes about a month for R&S to repair and return the module
- Plans to introduce our own test & repair setup in RF lab

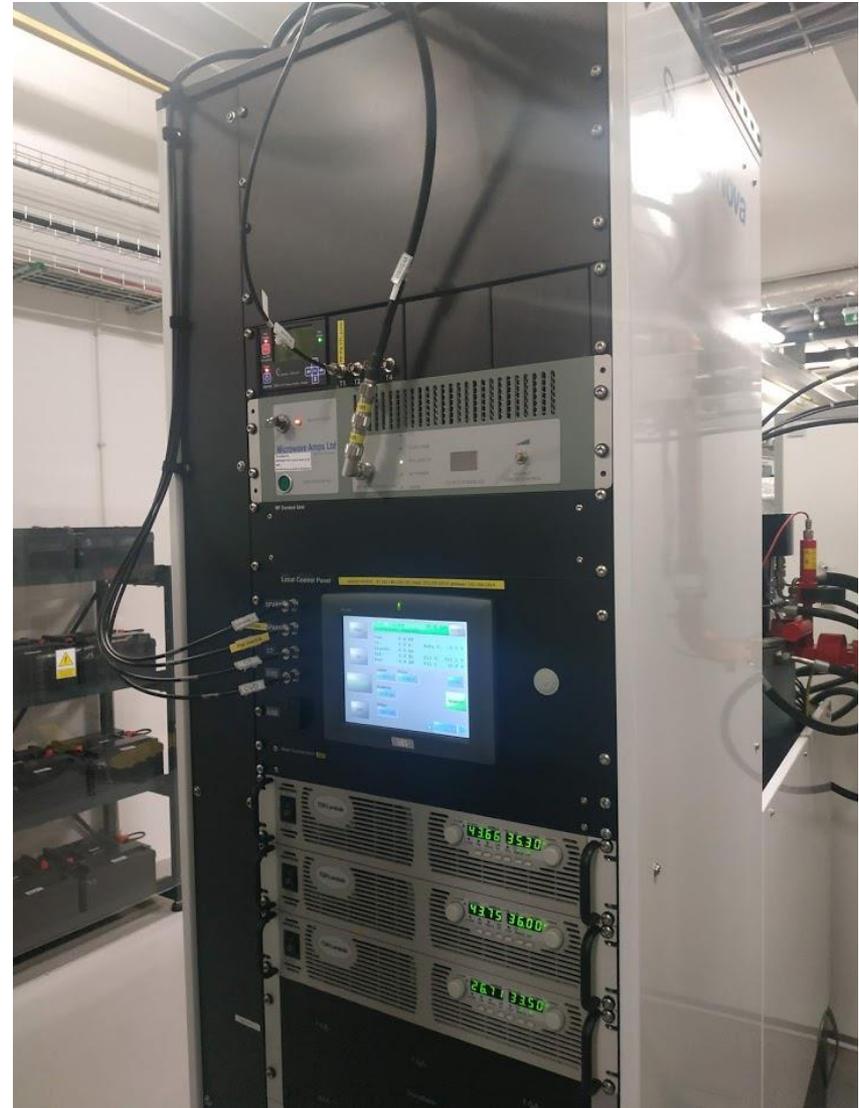
Modulator HMI panels aging poorly

- HMI Panels in modulators are working continuously for over 5 years
- Main screen burned itself permanently into TFT display
- Panels operate Win XP and are slow
- Counters for operation time run backwards (!?)

Difficult to get replacement panels as most use Win 7/10 nowadays.
No response from ScandiNova yet

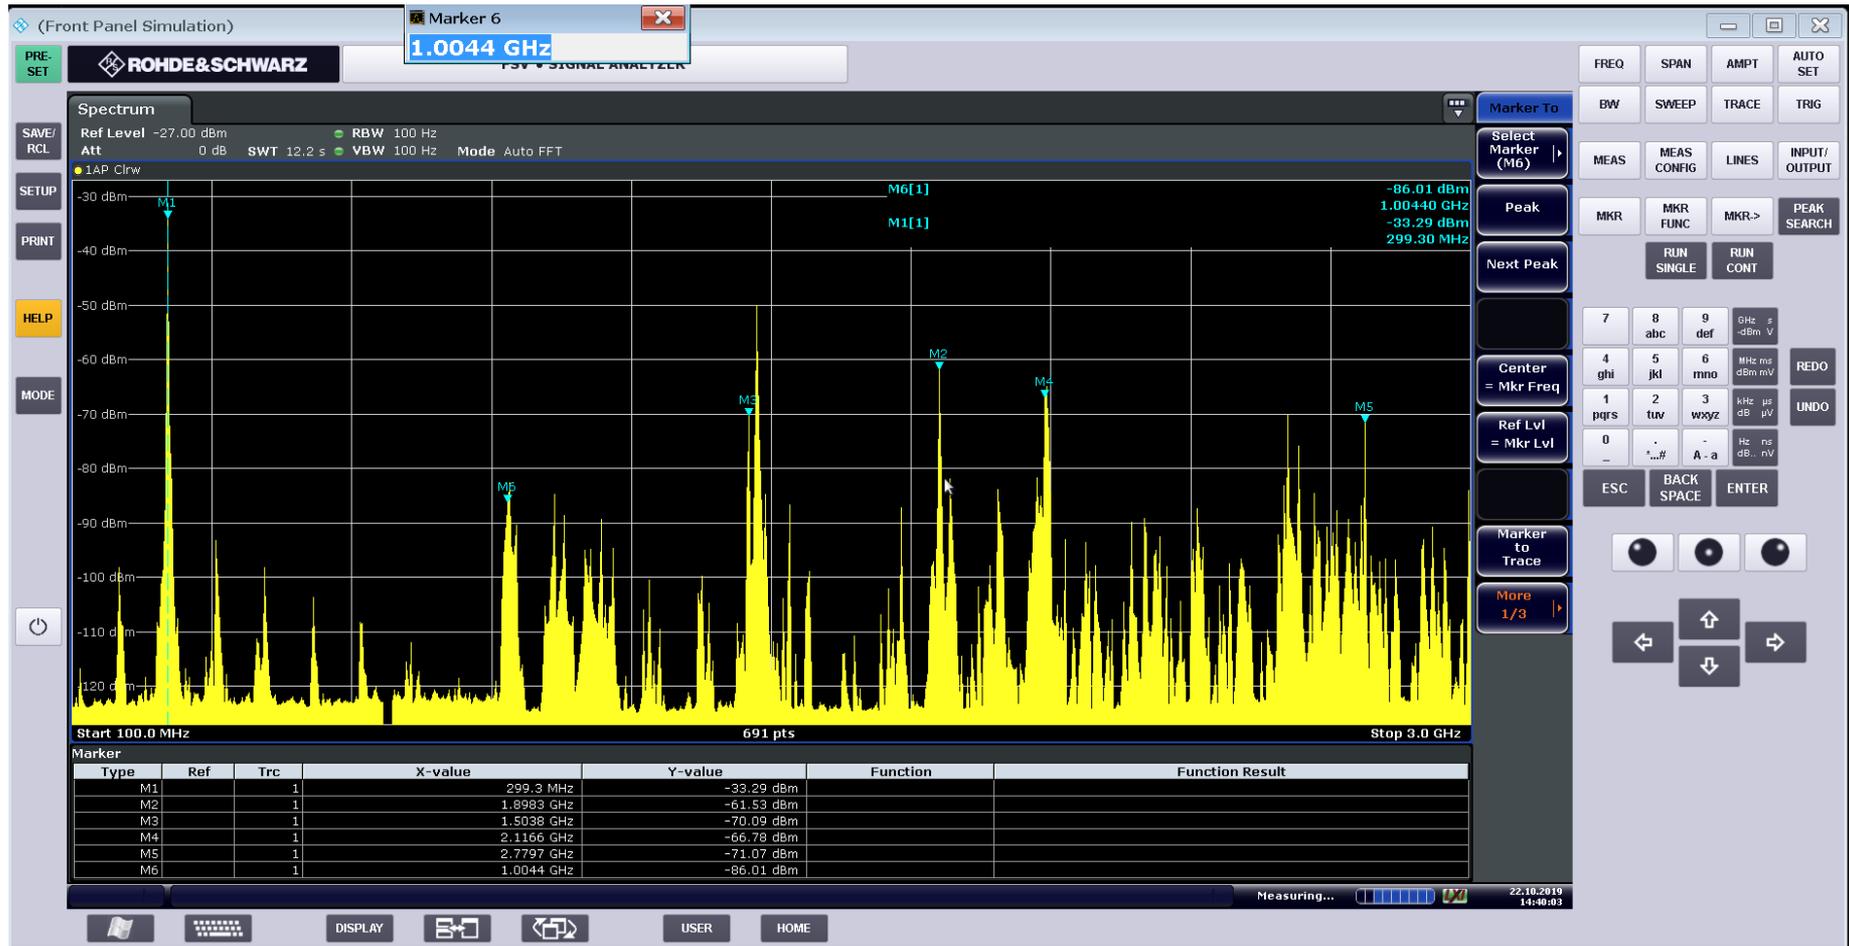
High concentration of harmonics in SR

Is this a matter of finding a better working point for the SR or does it mean we need HOM couplers?

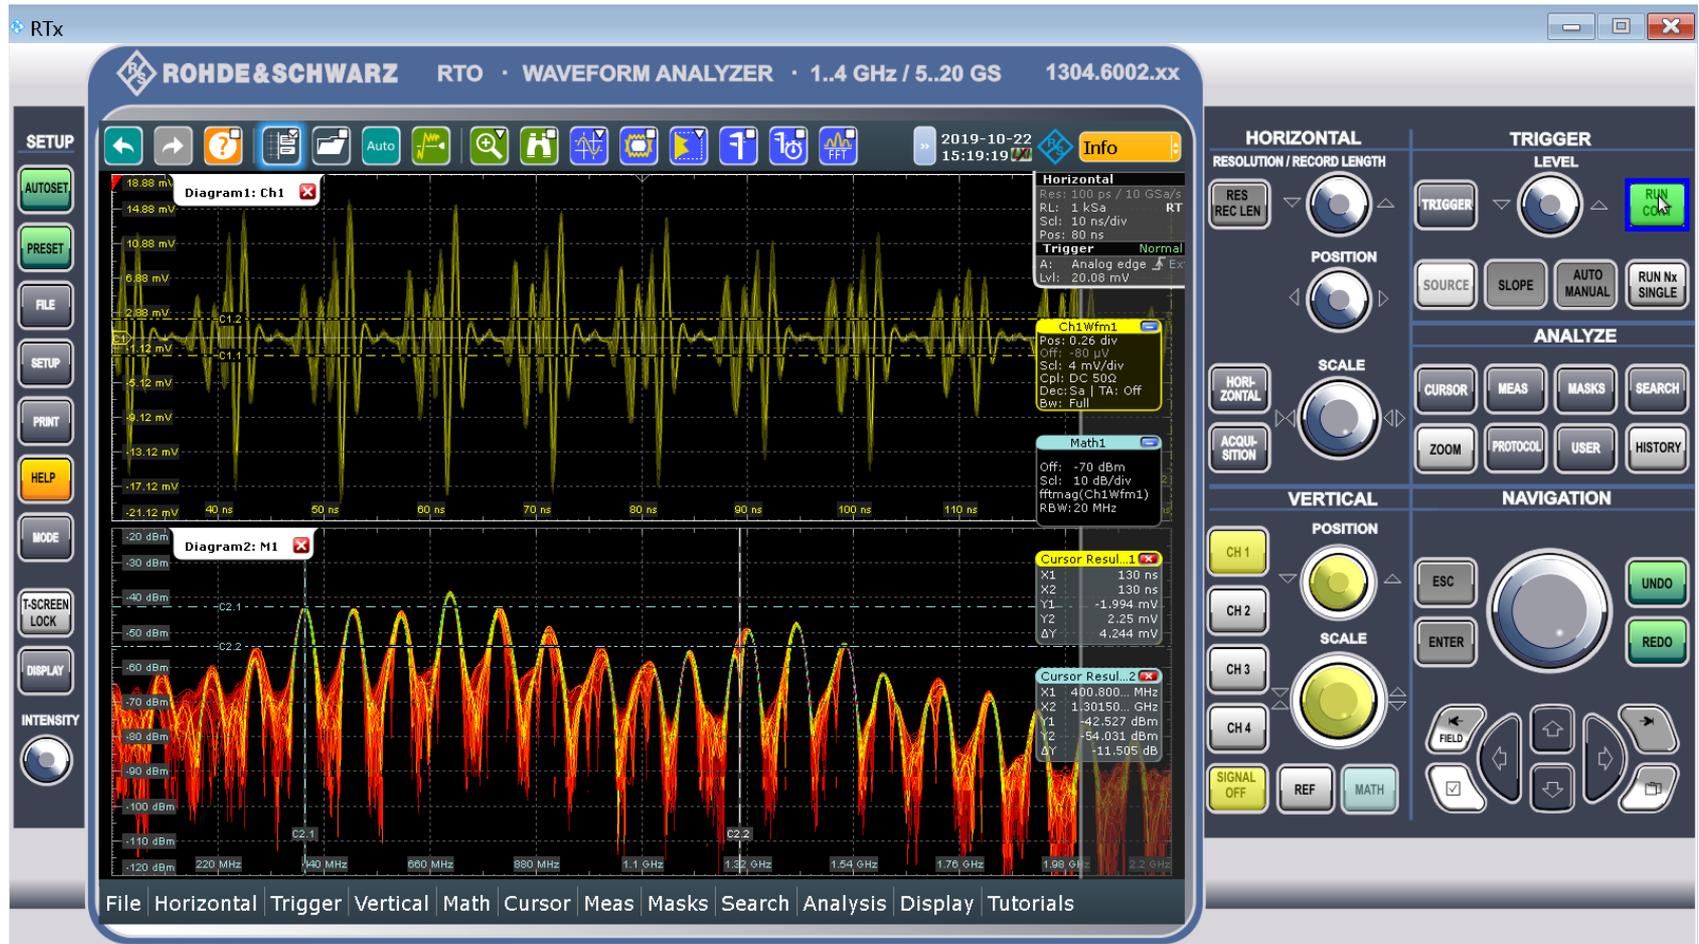
Bunch modulation

Filling pattern measured on striplines show 800MHz-1,3GHz modulation of individual bunches
