# ANKA RF System - Upgrade Strategies

ANKA Synchrotron Radiation Facility

2014 - 09 - 17

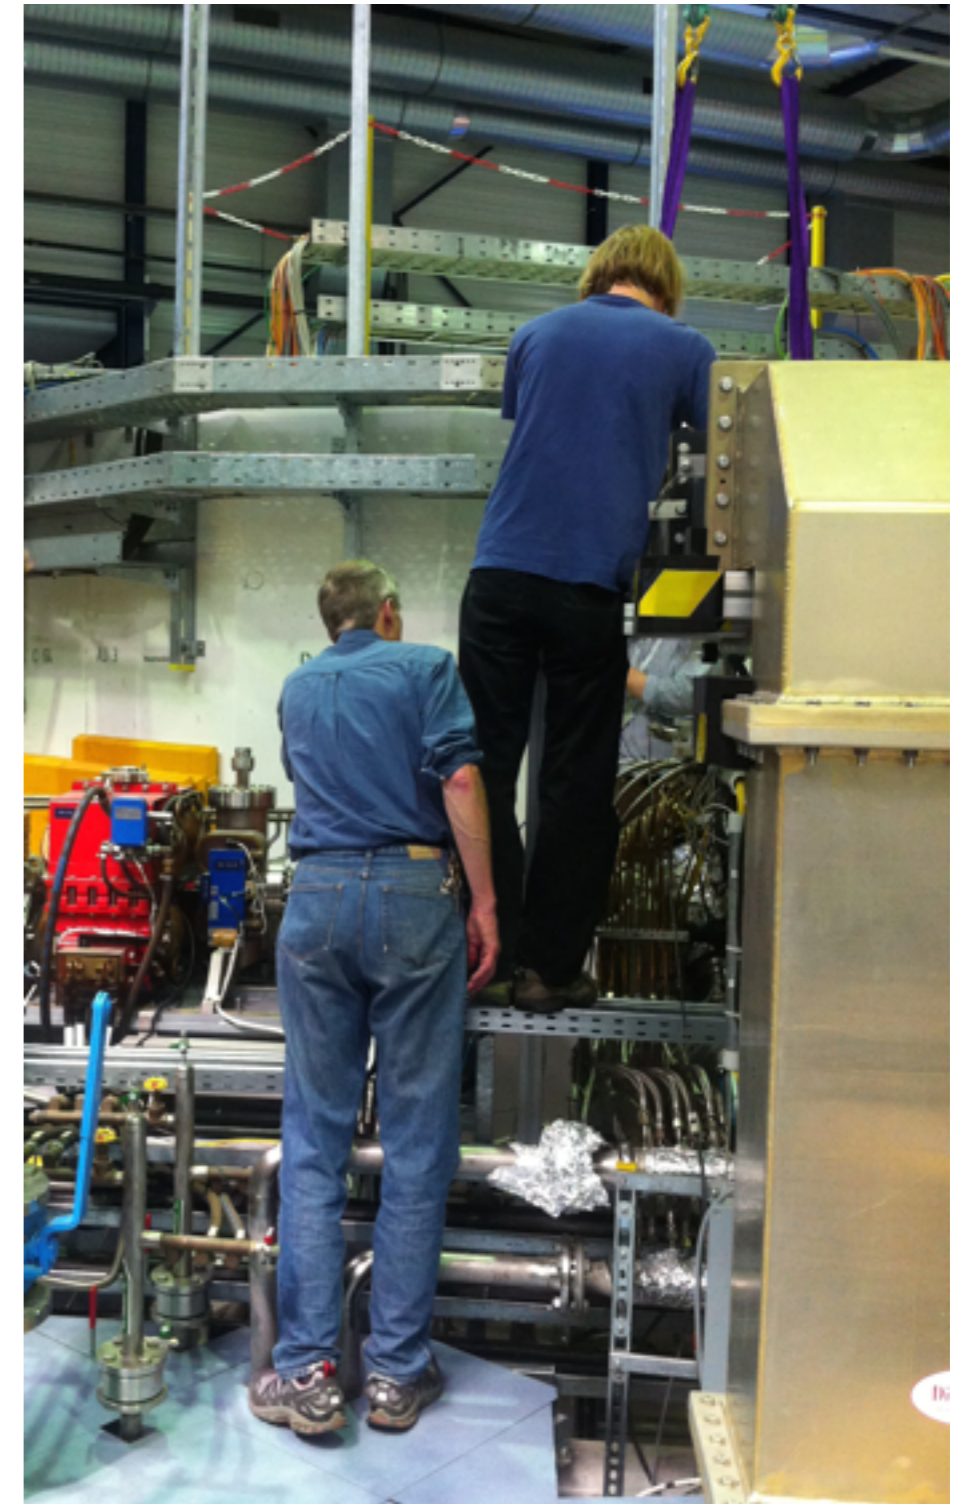
# Coupler window cleaning

- occasionally interlocks on outlet air temperature due to the high gap voltage in SUO studies
- Air-outlet: S2 26°C S4 29°C, Interlock: 35°C
- Assumption: deposition on ceramic window
- Exchange of experience with SLS:
  - ➔ mechanical cleaning of ceramic surface using the industrial 3M Scotch Brite
- Cleaning in January' 14: 1-2h per Cavity

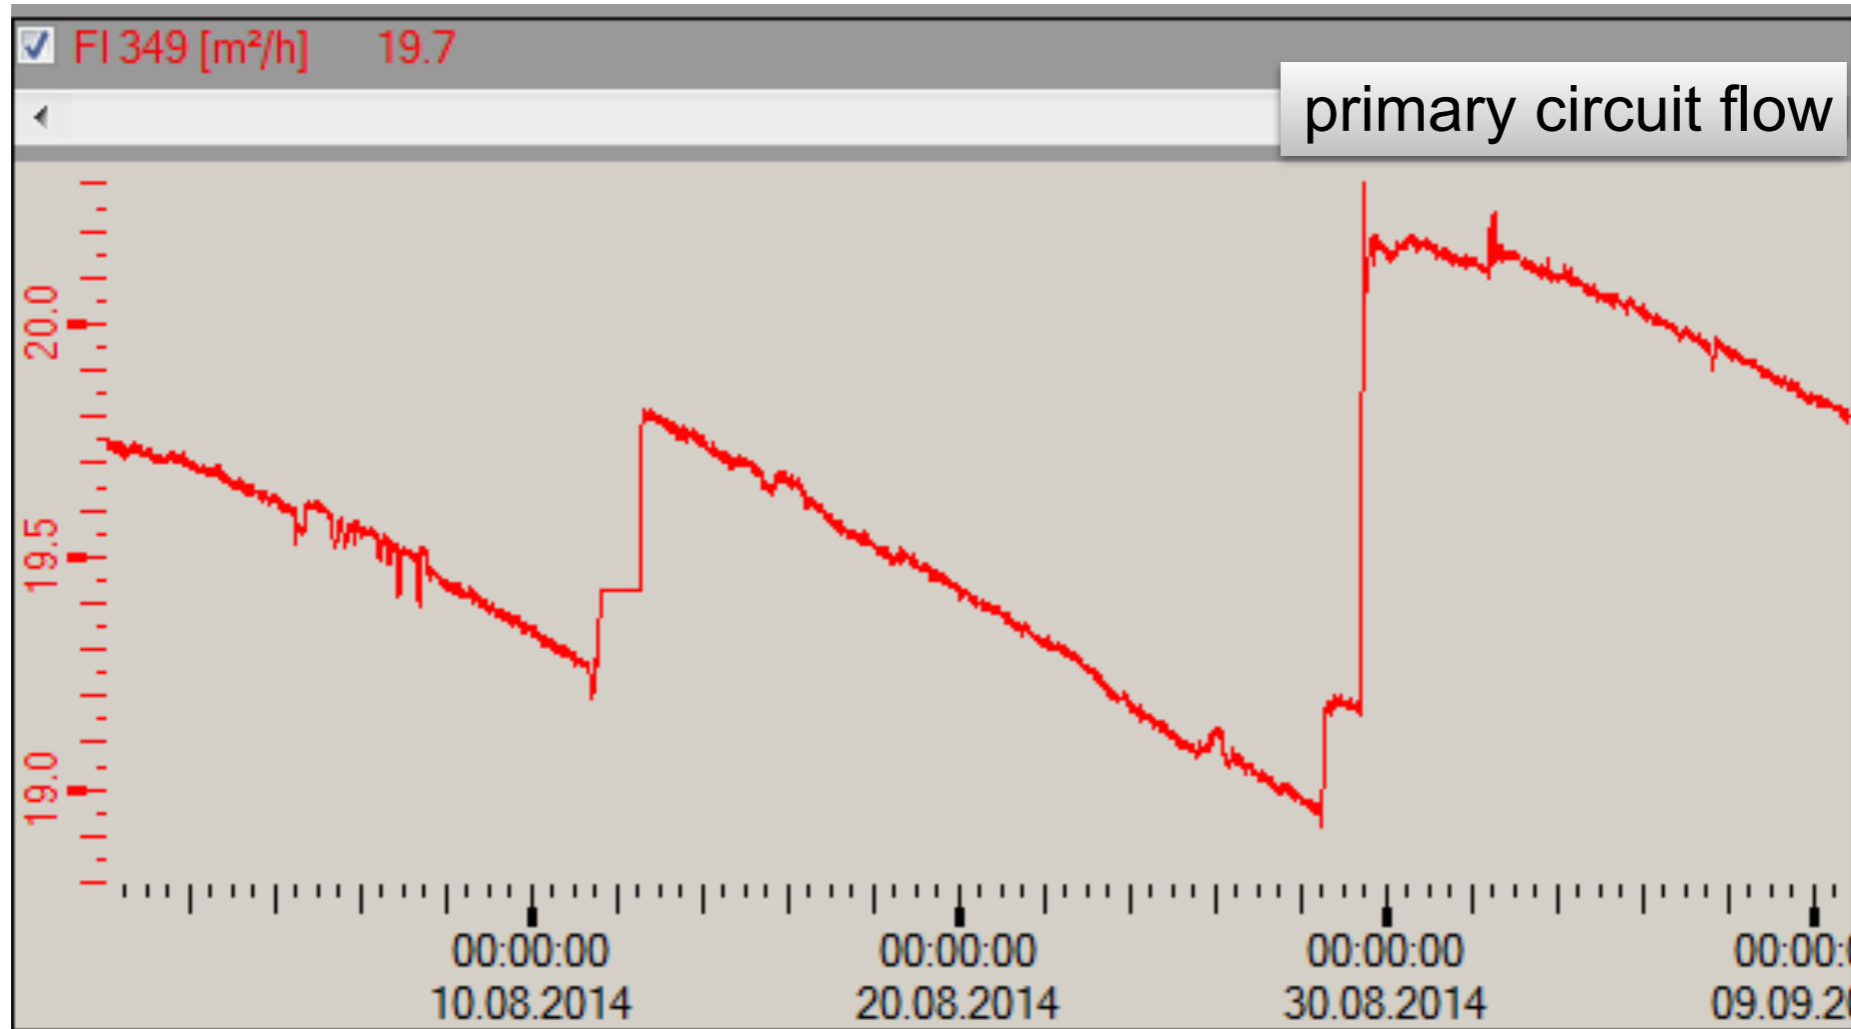
# Cooling Rack - Water Flow Rate

- Flow rate of primary cooling circuit is decreasing slowly in time
  - ➔ change of PID behaviour
  - ➔ temperature oscillations also in secondary circuit
  - ➔ reduction of acceptable ramping rate (kV/s)
  - ➔ crossing HOM e.g. during ramping

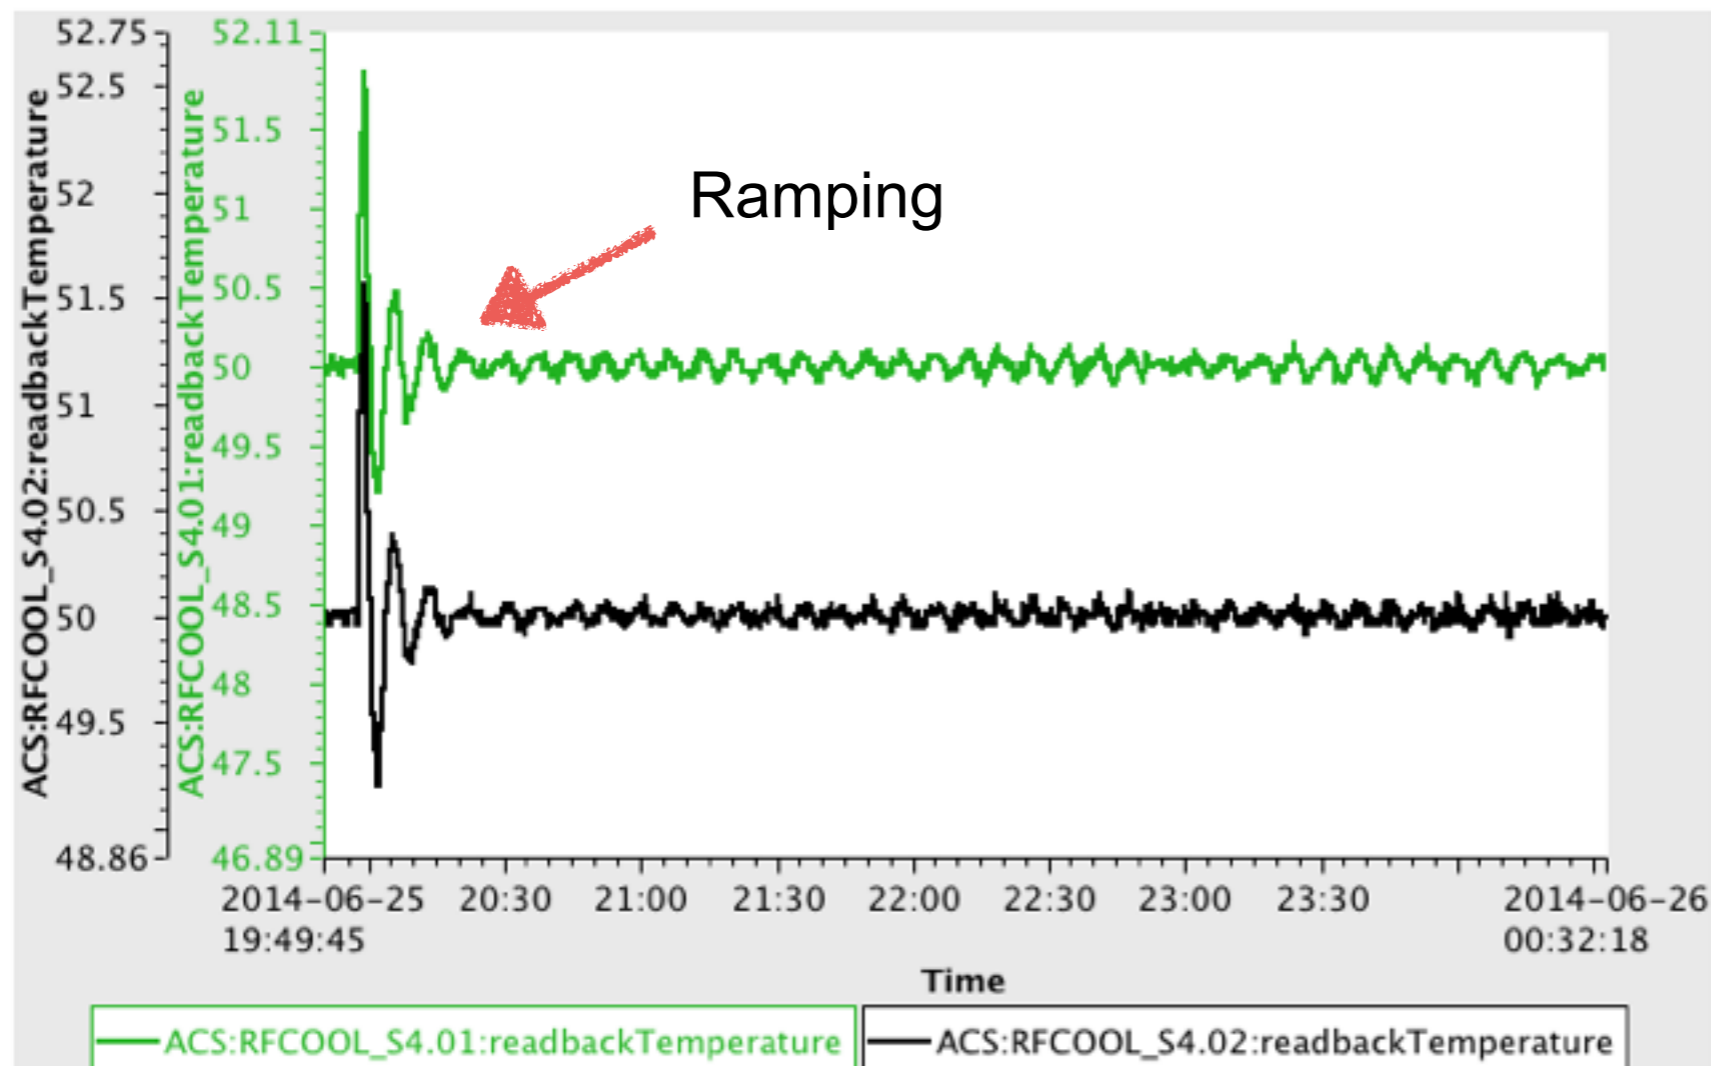
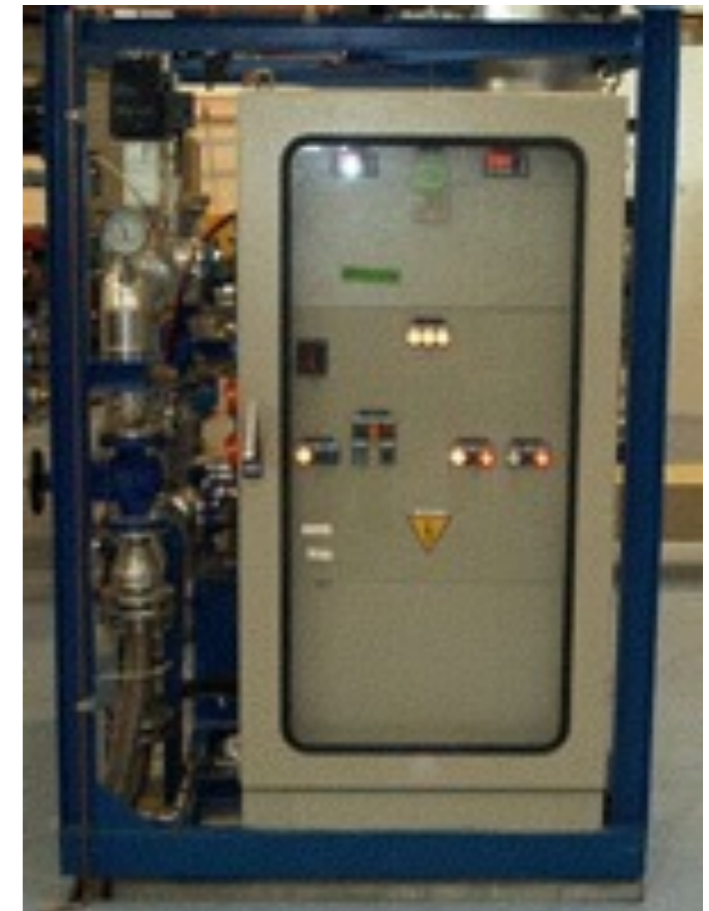
# Cooling Rack - Water Flow Rate

- Disturbed PID regulator due to energy ramping oscillates
- critical for special user operation in low alpha mode -> change of peak voltage  
-> change of bunch length -> change of THz radiation/bursting behaviour

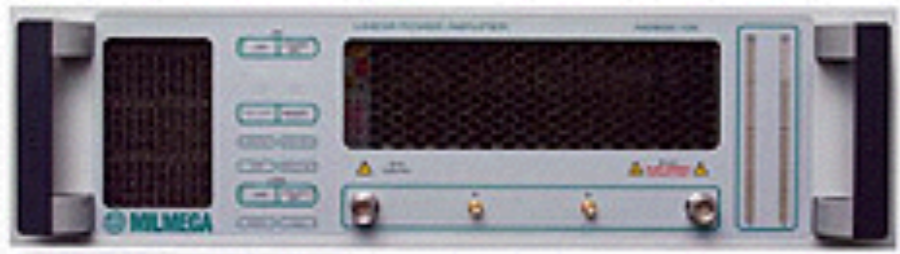
# BBB Longitudinal Kicker

- Initial BESSY/DELTA design
- tapers to ANKA beam pipe profile
- additional copper absorber
- suitable broad band amplifier:
  - ➔ ~200W 1.0-2.0 GHz
  - ➔ e.g. MILMEGA AS0102

installation planned for  
the end of the year

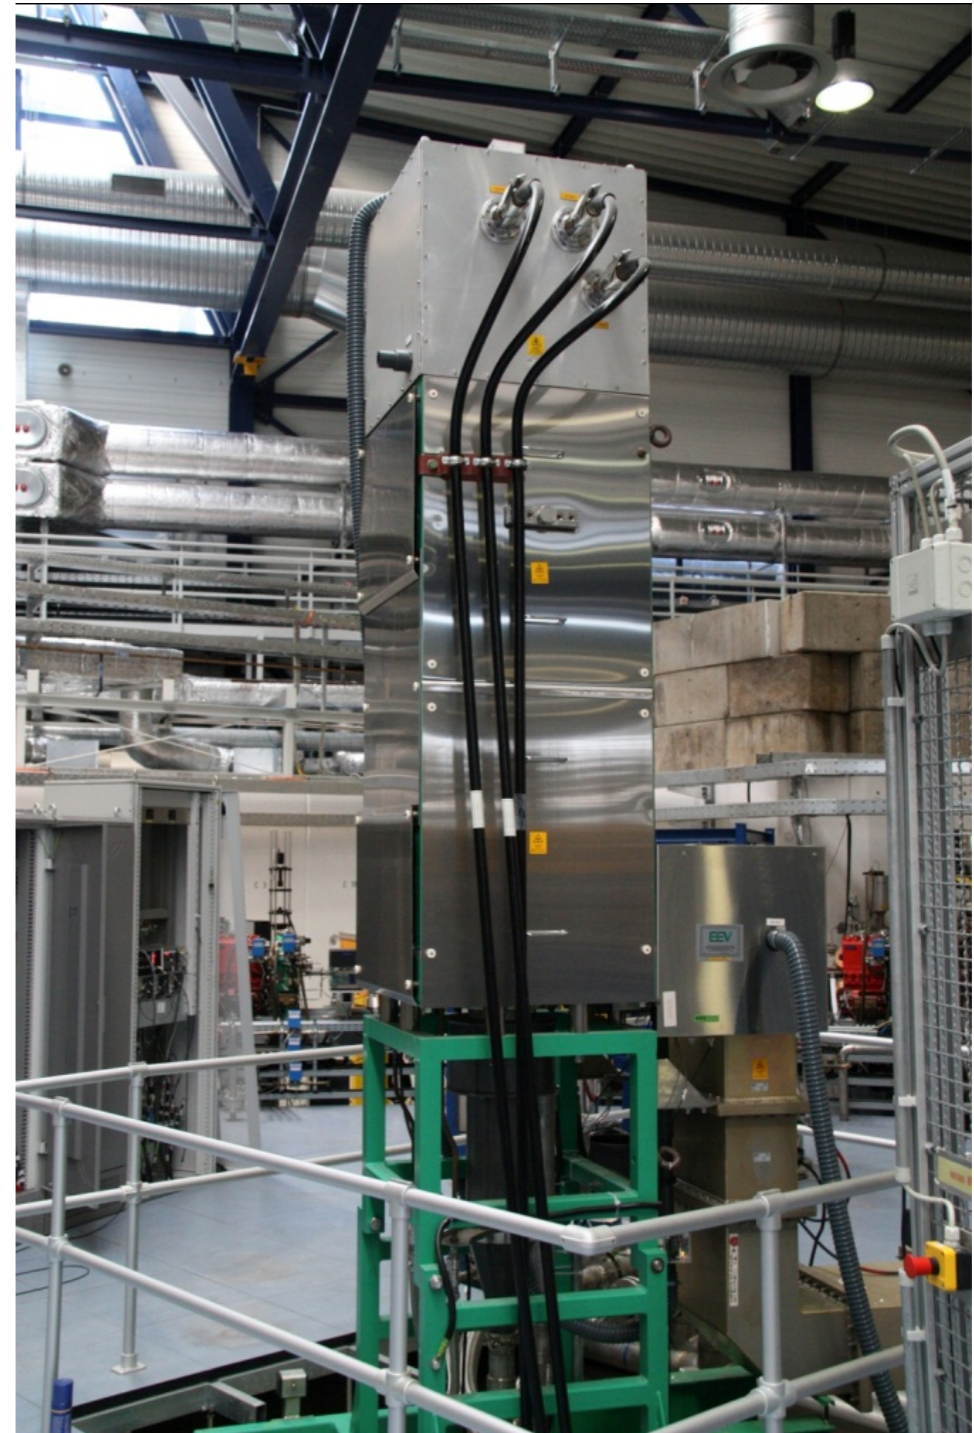
# Klystron Service

- Sudden beam losses occurred
- RF drive reflected power increased:
  - ➔ maintenance of klystron was performed
  - ➔ replacement of RF cable inside of lead cover was done
  - ➔ last replacement 2011: wrong material

**radiation hardness of dielectric material is important issue**

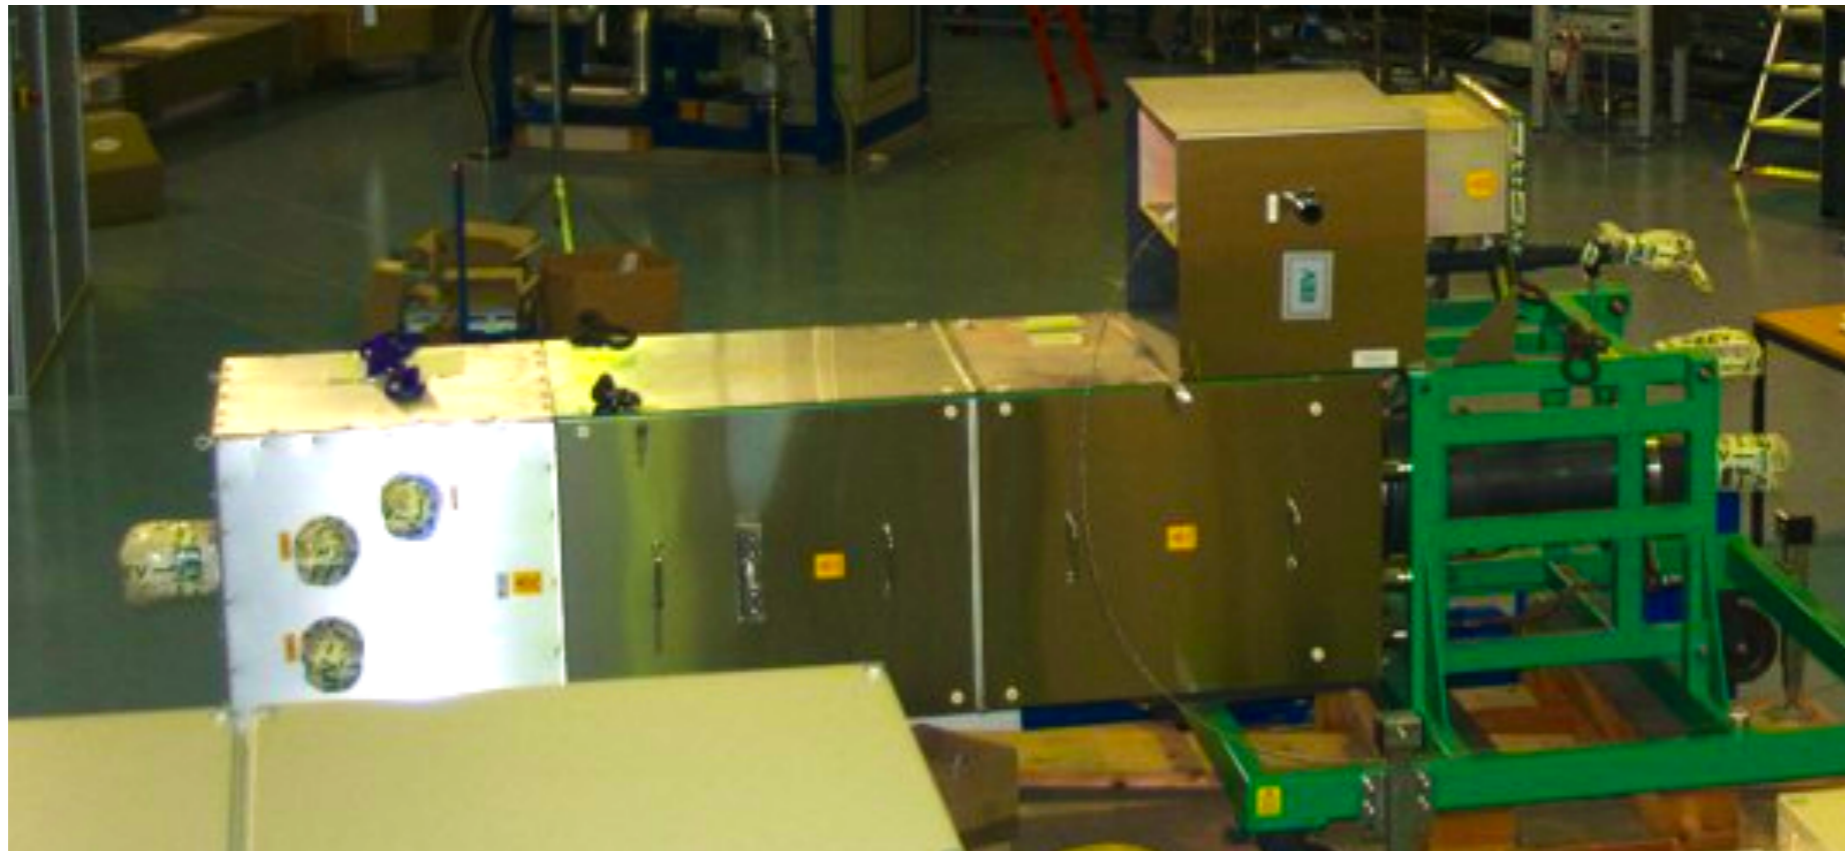
# Spare Klystron

- life time of klystrons is long but not endless
- spare klystron for ANKA is on stock, but:
  - ➔ is it operable? what is the on-stock lifetime?
  - ➔ vacuum is maintained, but not the heater
- 500 MHz klystron refurbishment could be issue in the next future

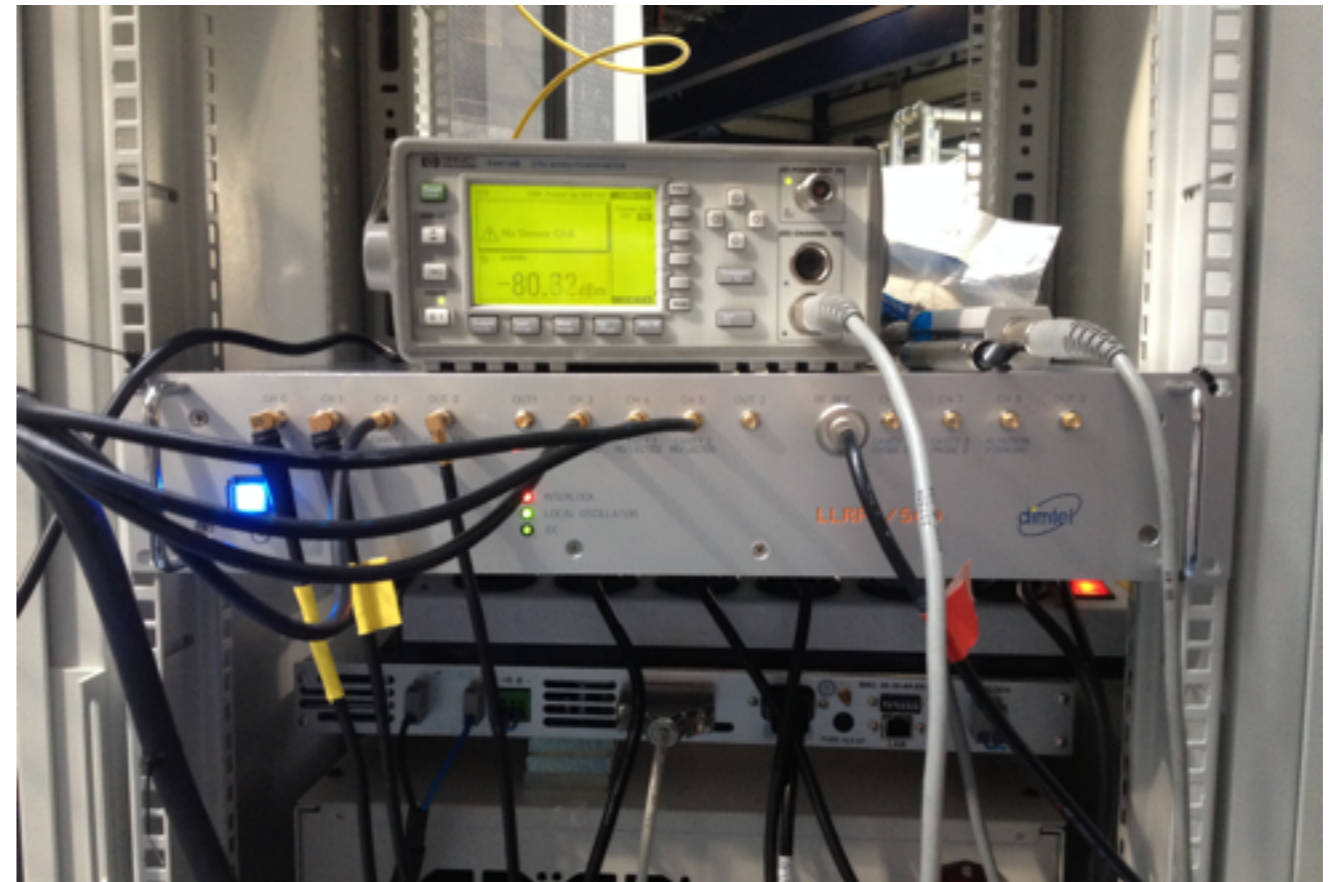
# DIMTEL LLRF Test at ANKA

- 1st experience exchange with ELSA
- station S4 was chosen for the test
- constrain:
  - ➔ 1 day MP scheduled
  - ➔ minimal invasive setup
- full installation within 2 hours
- tuner controllability was realised by workaround via EPICS2ACS
- Test passed:
  - ➔ general functionality
  - ➔ open loop / closed loop
  - ➔ rf ramp up/down
  - ➔ soft interlocks + diagnostics
  - ➔ 100mA beam + ramping to 2.5 GeV only 6h after installation (!)

2x CavFWD, 2x CavREF, 2x CavPick-Up  
 interlock daisy chain (TTL), 1x Drive out  
 3 inputs and 3 outputs leaved free,

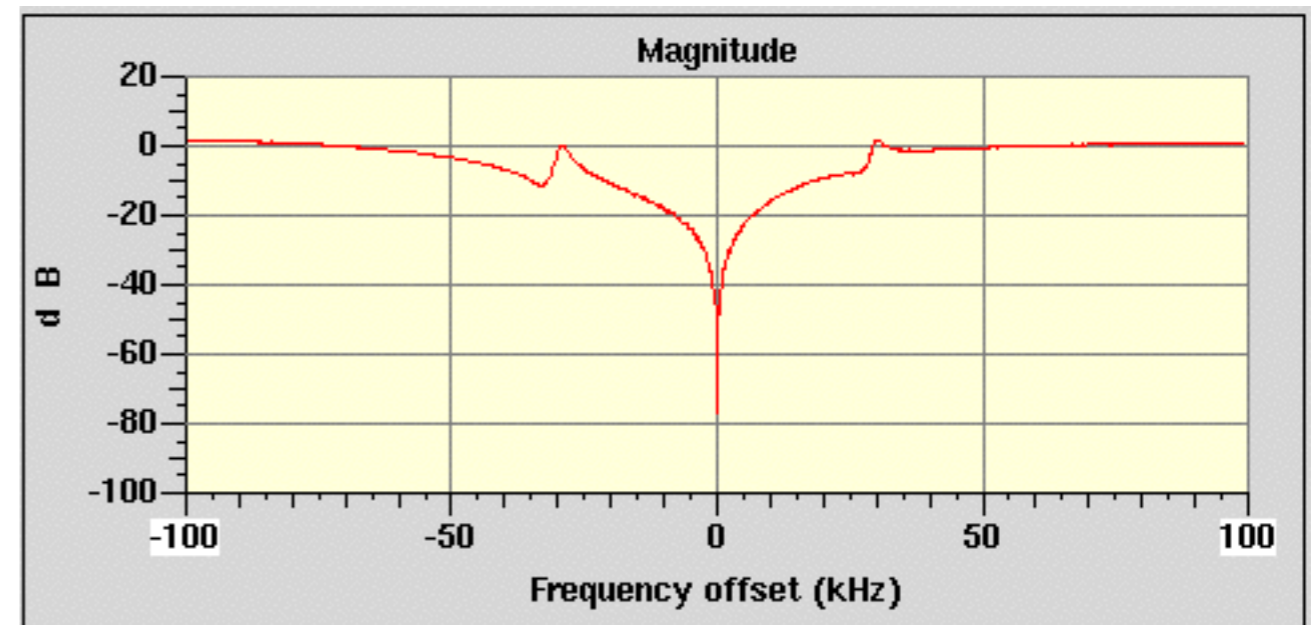
# DIMTEL LLRF Test at ANKA - Results

- Closed loop transfer function
  - ➔ Measured from set point to error signal
  - ➔ quantify disturbance rejection
- proportional and integrator loops produce high rejection at low frequencies
- closed-loop disturbance rejection
  - ➔ beam response at 30 kHz
  - ➔ -70 dB rejection at ~30 Hz
  - ➔ -15 dB rejection at 10 kHz

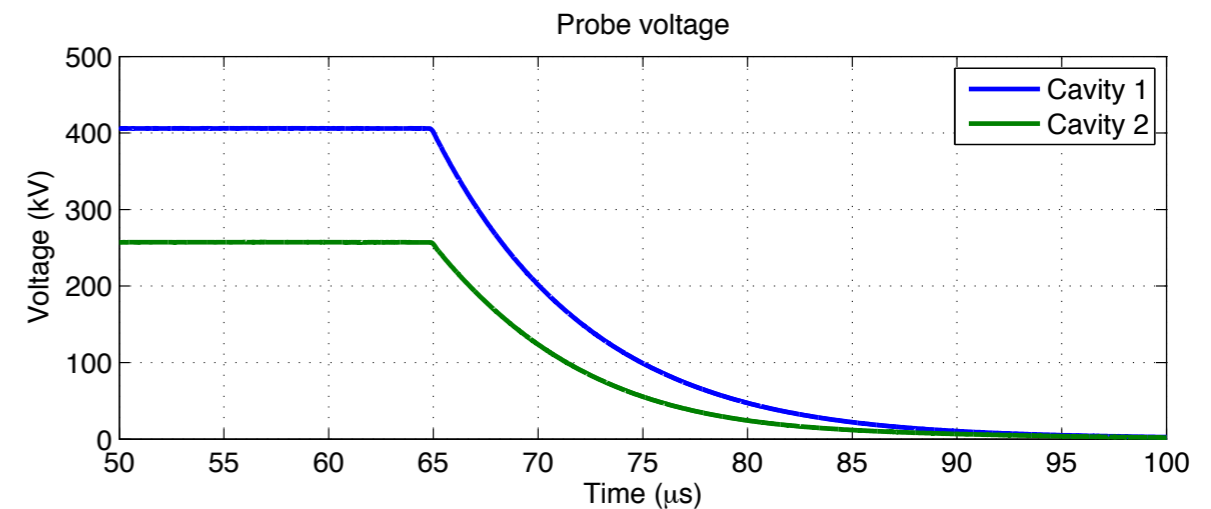
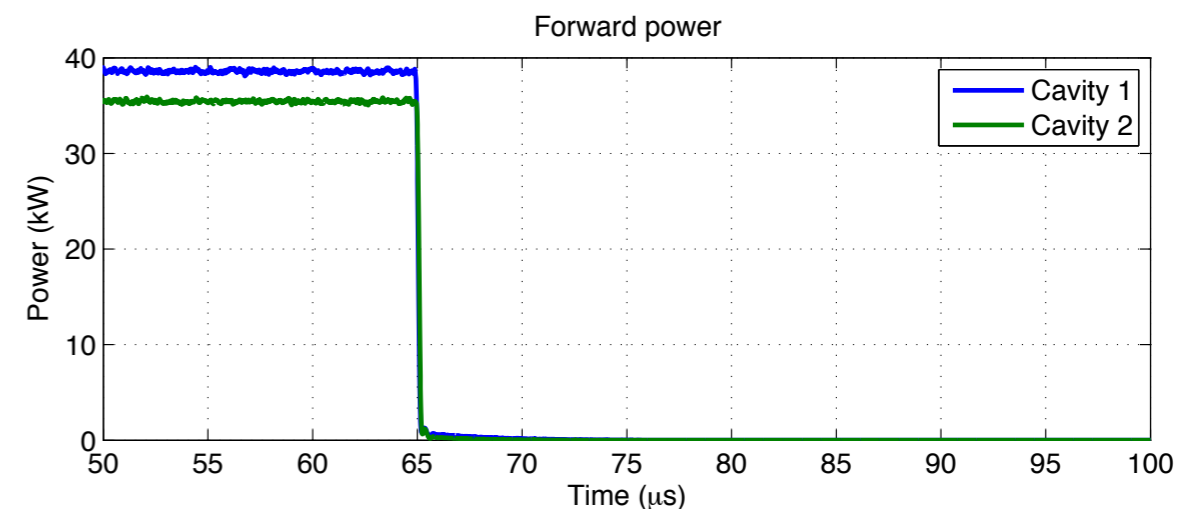
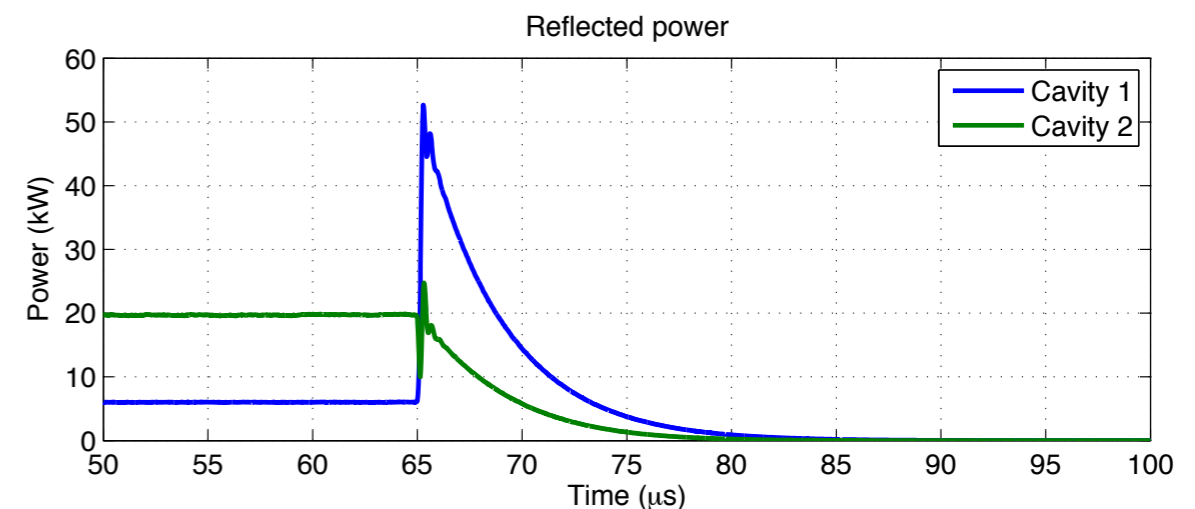
# DIMTEL LLRF Test at ANKA - Results

- post-mortem analysis
- manually detuned cavity 2 to reach reflected power interlock (20kW)
- RF drive switched off within 100ns
- Reflected power rise up shortly
- Field decay transients can be used for calculating of Q and detuning:

Parameter	Cav. 1	Cav. 2
Detuning, kHz	-3.8	-29.4
Loaded Q	11375	10630
